# **INDOOR AIR QUALITY ASSESSMENT**

**Newman Elementary School  
1155 Central Street  
Needham, Massachusetts 02492**

Prepared by:  
Massachusetts Department of Public Health  
Bureau of Environmental Health  
Indoor Air Quality Program  
May 2008

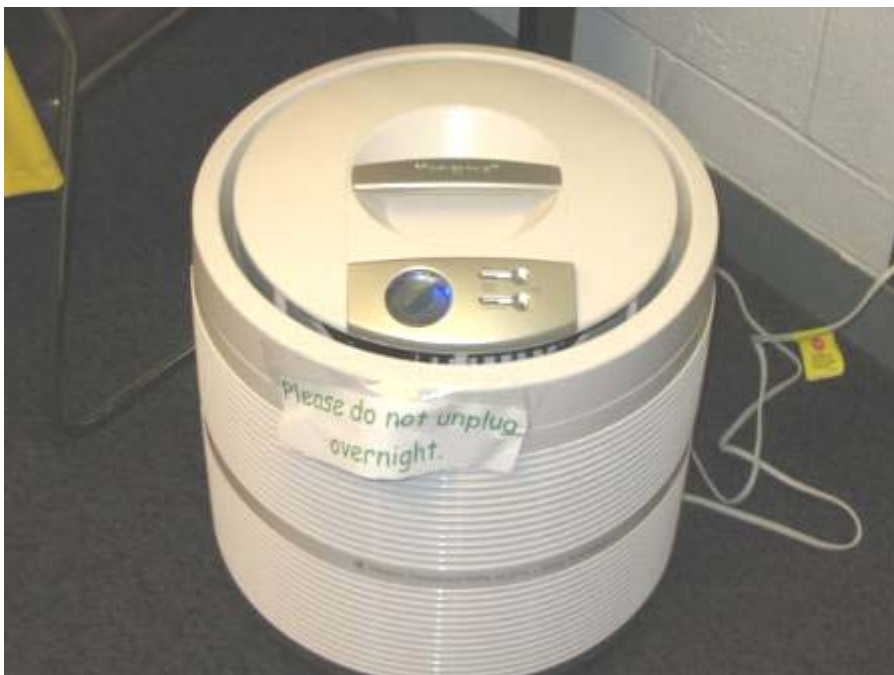
**Picture 38**

High efficiency particulate air (HEPA) purifiers were observed on the floor in several locations (Picture 38). Air purifiers should be placed within the breathing zone rather than at floor level. In addition, this equipment is normally equipped with filters that should be cleaned or changed as per manufacturer's instructions to prevent build up and re-aerosolization of dirt, dust and particulate matter.

**HEPA-filtered air purifier placed on the floor**

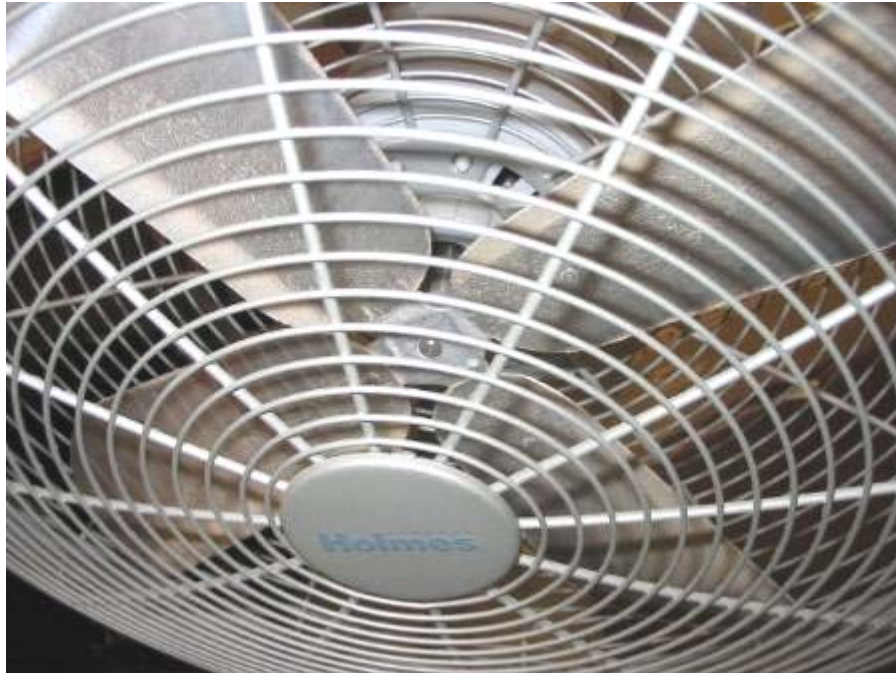
**Picture 39**

Finally, several personal fans and return/exhaust vents were occluded with dust and debris (Pictures 39 and 40). Dust can be a source for eye and respiratory irritation. Re-activated personal fans can serve to distribute dust. If exhaust vents are not functioning, backdrafting can occur and aerosolize dust particles. At the time of assessment, BEH staff recommended vacuuming exhaust vents for rooms 407 and 409 with a HEPA-filtered vacuum.

**Personal fan with dusty fan blades**

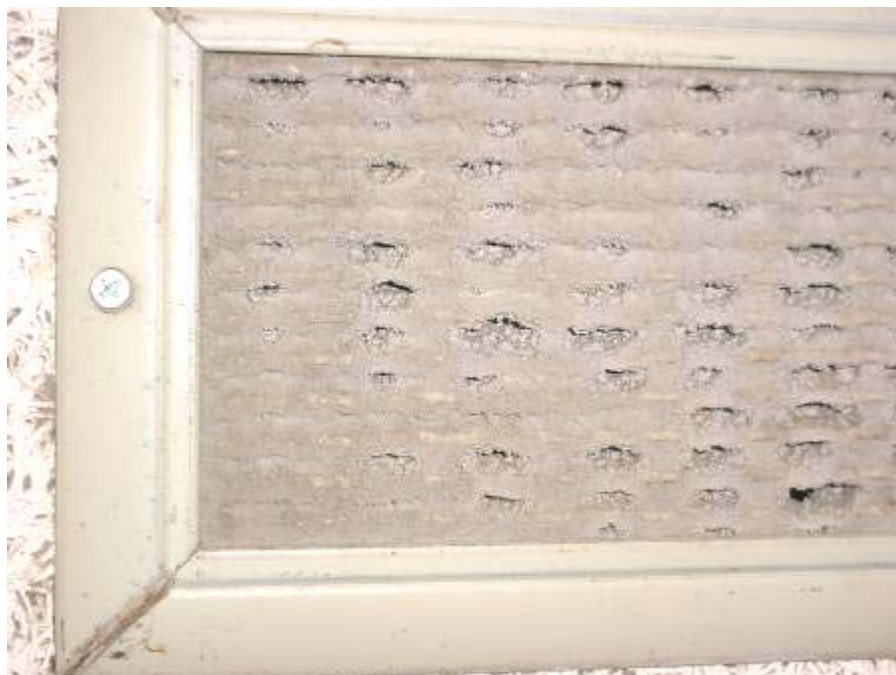
**Picture 40**

**Exhaust vent occluded with dust**
